# Garrison Diversion Operations and Maintenance: Snake Creek Pumping Plant

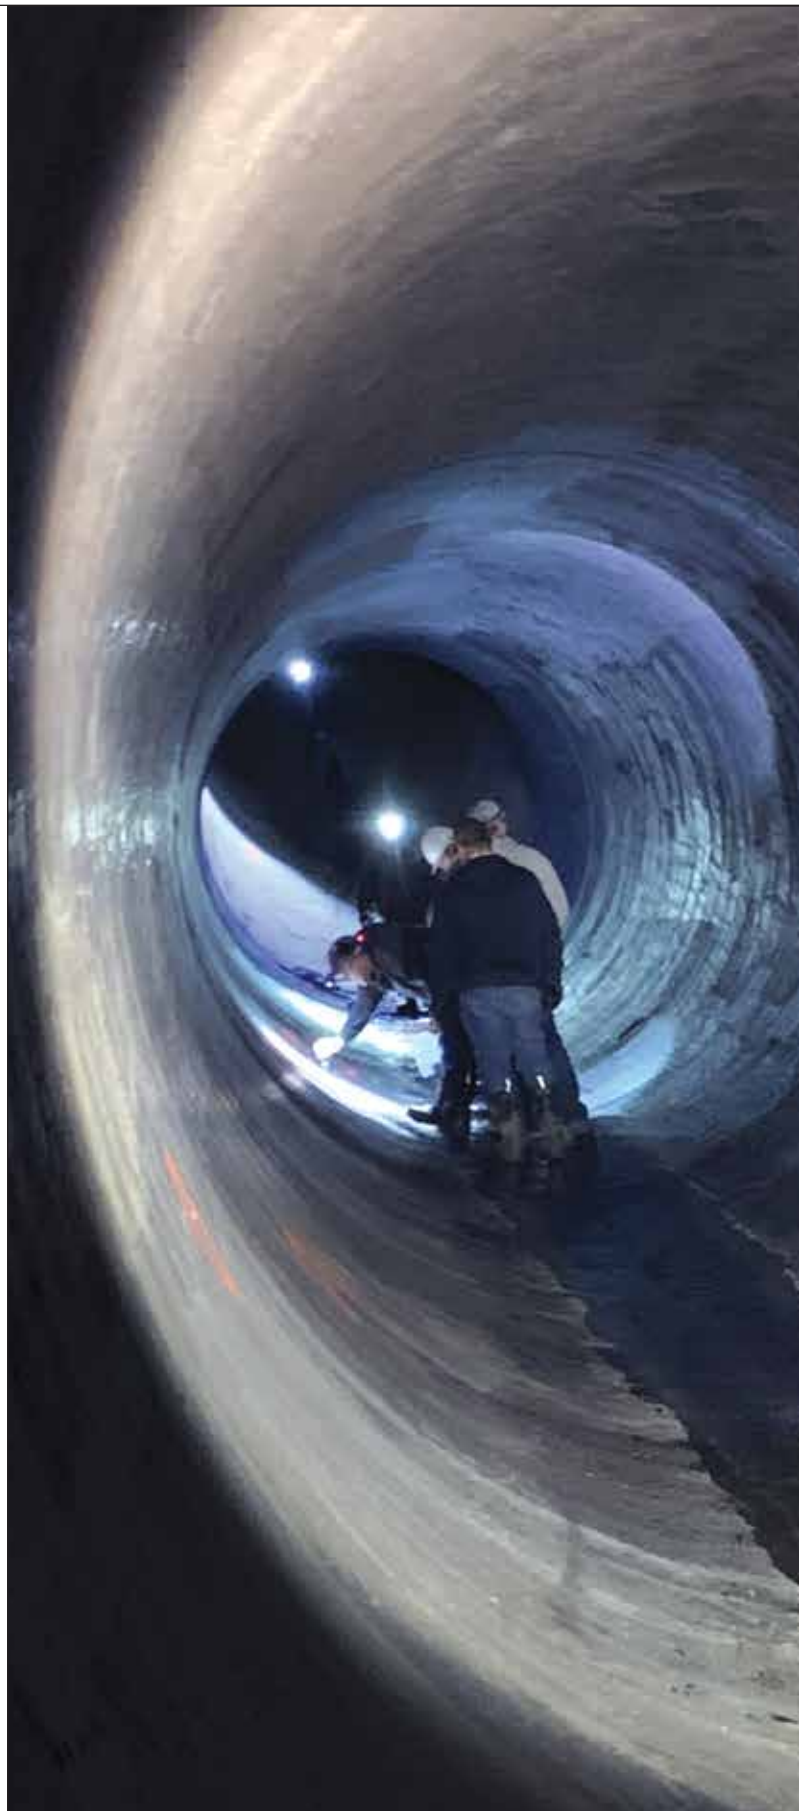
Once dewatered, pre-inspection of the existing coating begins, which involves walking the length of the tunnel and marking any areas needing further inspection. On the pipe's interior, several locations of the coating were peeling and chipping, requiring attention. Corrosion was present on the pipe's exterior where the suction tube steel contacts the concrete.

*Pre-inspection of tunnel and marking suspect areas.*

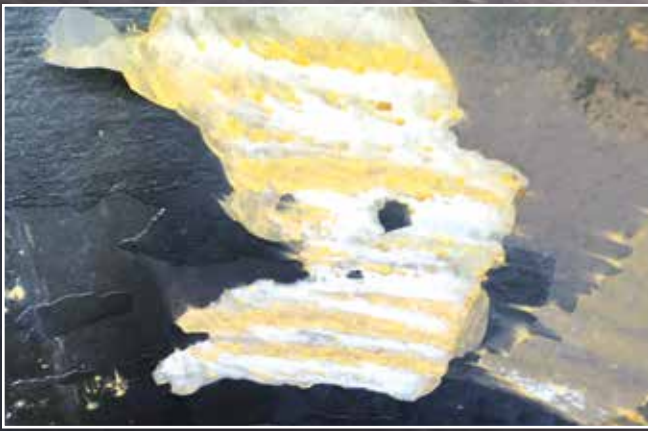
*Example of area needing attention.*

Garrison Diversion staff preps the areas for new coating by scrub cleaning the failed areas with water and brushes, then sandblasting those areas down to bare metal. Sediment that has collected inside the pipe is cleaned out.

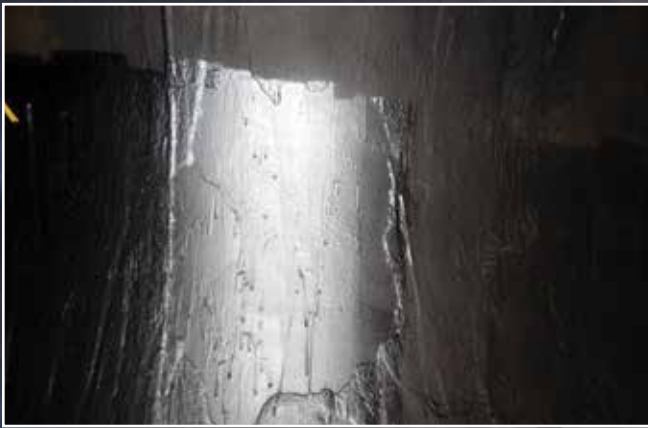
*Example of recoated area.*

Williams Corothane I – Coal Tar, applied with 12 to 24 hours in between coats. Coating measurements are recorded and logged after each coat is applied, and measure roughly seven mils in thickness when completed.

On Unit 3’s exterior, the areas were sandblasted and recoated with Sherwin Williams Corothane I-MIO Aluminum. The manhole doors were sealed with Permatex The Right Stuff Gasket Maker and the exposed exterior portions of the suction tubes of all three units were recoated.
